Customer Water Authority, North West
Sector Water / Wastewater
Date July 1997
Ref no. 10621

APPLICATION EXAMPLE

Rebuild of concrete trough

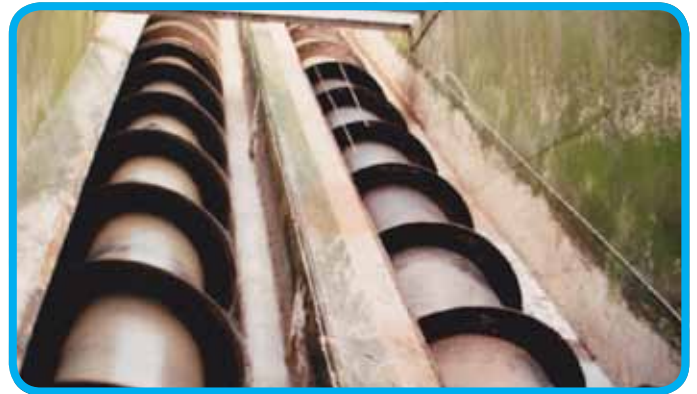
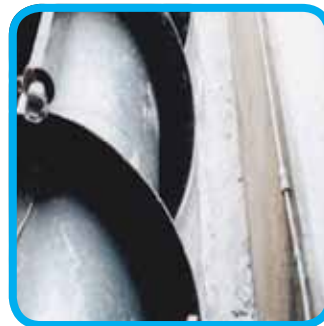
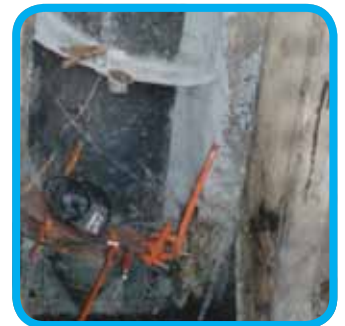
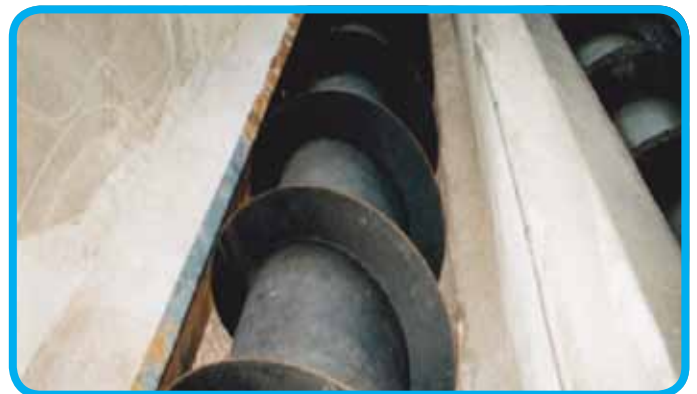
A collapsed bearing in the main screw drive had led to the screw slowly wearing away the concrete trough up to the point where the clearance from the screw tip to the trough wall was almost 20mm against the original spec of 6mm. The length of damaged area was around 5 metres.

The screw was operating at 30% reduced efficiency, and power consumption increased dramatically.

A repair technique was devised whereby, 6mm bars were tack welded onto the screw blade tips. The area to be repaired was primed and the epoxy based concrete repair material was introduced whilst the screw was turning slowly. The flat bar plates effectively reformed the original profile with the net result being the required 6mm was recreated once the material had fully cured and the forming bars were removed.
