**Customer** Ship Repair Yard, North West  
**Sector** Marine  
**Date** December 2011  
**Ref no.** 20022

## APPLICATION EXAMPLE

# Repairs to bow thruster

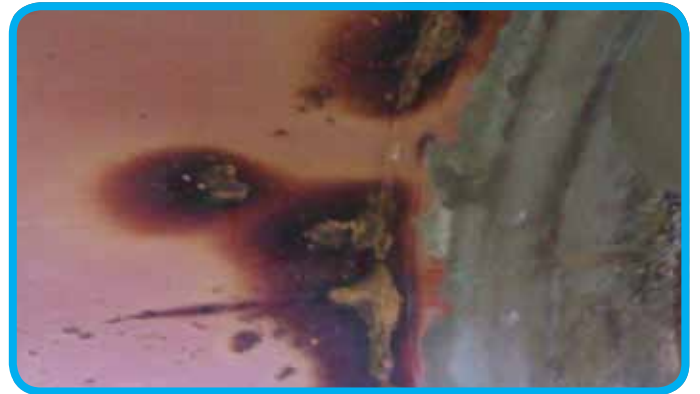
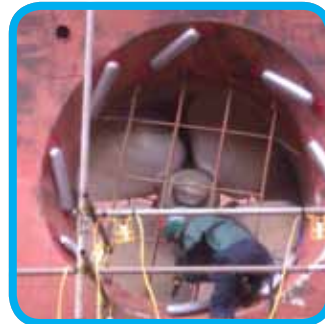
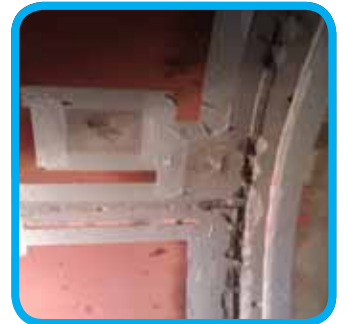
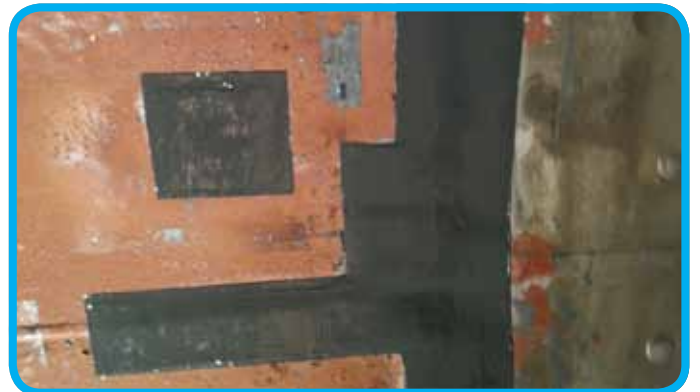
On dry docking this offshore supply vessel was inspected and found to have severe cavitation and corrosion on the bow thrusters wear rings and welds. This high erosion area is an integral part of the ships steering particularly when docking.

If left untreated the corrosion would get worse leading to the need to replace the liner at considerable expense and extra time in dry dock, and the worst case scenario is leak to the hull.

The complete circumference was blasted to SA2.5 with a 75 micron profile as a minimum to establish the extent of the corrosion. Upon inspection the Ships Manager approved the use of Resimac ceramic repair paste to fill the deep areas back to the original spec, and for a ceramic repair fluid to be applied to protect the repaired areas.

Mark Specialist Applications was considered as the "only option" on this occasion due to the limited time available before taking on water. Temperature controlled environments were erected, heaters installed and works completed with 12 hours with a further 16 hours for post curing before immersion.
