**Customer** Flour Mill, North West  
**Sector** Buildings & Structures  
**Date** July 2011  
**Ref no.** 10999

# Repairs to diesel tank bund

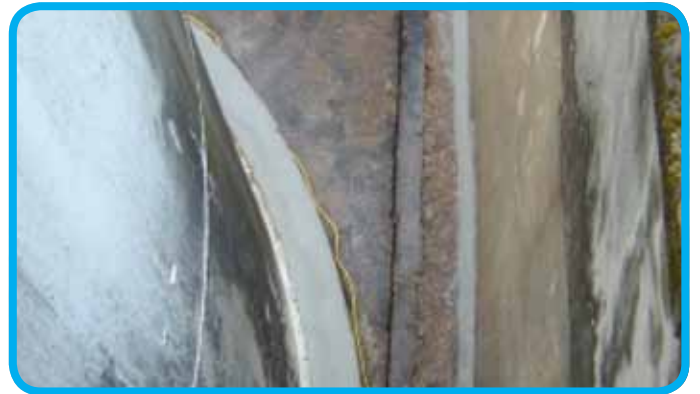
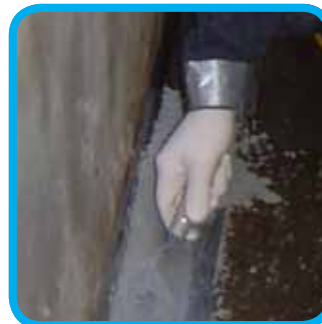
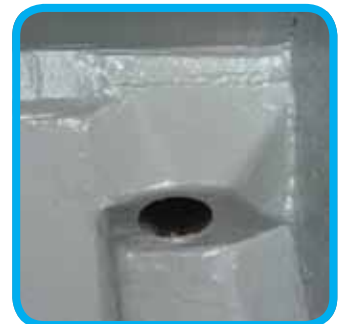
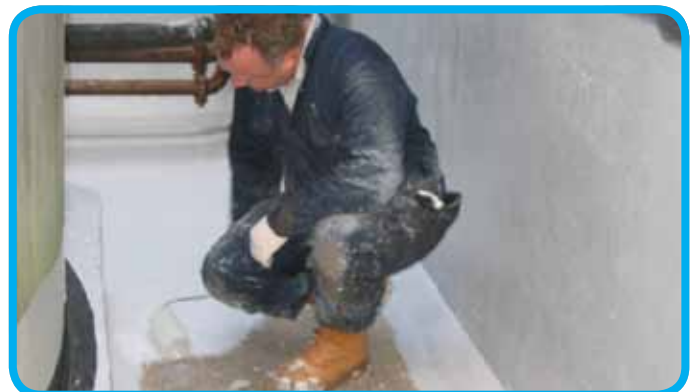
The emergency generator diesel tank bund was found to be in need of repair. The overall concrete required sealing, the wall to floor interface was identified as a leak path and several pipe penetrations were deemed as not fluid tight.

A leak from the diesel tank could easily have passed the bund entering the surface water drains leading to an environmental occurrence.

The bund was high pressure washed, the wall/floor interface received a fillet of epoxy repair cement, the pipe penetrations were sealed and the area received 2 coats of epoxy lining.

The volume capacity of the tank was calculated and we found that only the bottom one metre would see diesel in the event of a spillage, we therefore coated only this section. The client was delighted as other contractors quoted to line the whole bund.
