Customer Military Vessel - Ship Repair Yard, NW
Sector Marine
Date January 2012
Ref no. 20025

APPLICATION EXAMPLE

Repairs to 42" engine cylinders

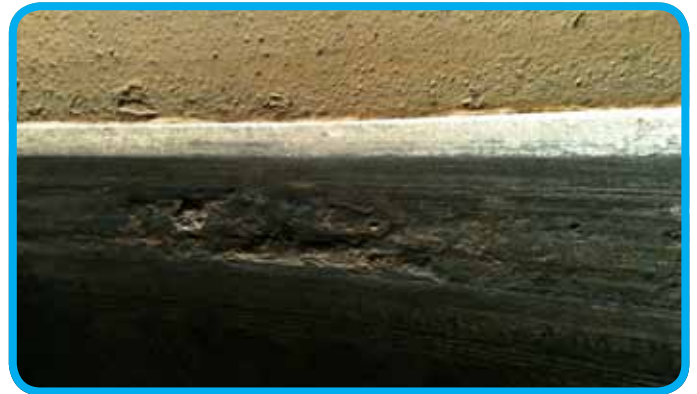
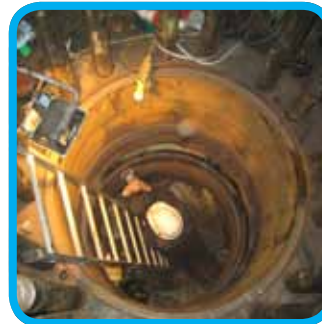
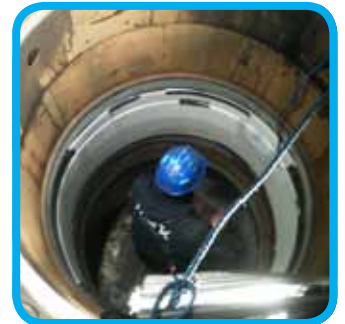
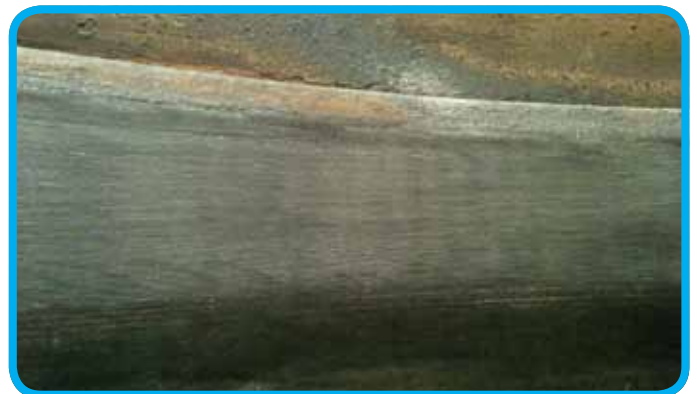
During a major re-fit of the vessel it was discovered that the engine block was passing water past the O-rings in each of the eight 42" cylinders. Cooling water had been passing the sealing face and contaminating the oil. Before the engine could be re-built the O-ring sealing faces had to be repaired.

The corroded rings (three in each cylinder) were blasted using a vacuum blast system to keep the dust to a minimum. Each O-ring sealing face was re-built using Resimac metal filled epoxy paste and left to cure. The cured material was then sympathetically hand dressed back to specification by highly skilled technicians.
