Customer Electricity Supplier, North West
Sector Power Generation
Date April 2012
Ref no. 20036

APPLICATION EXAMPLE

Damaged insulator – sub station

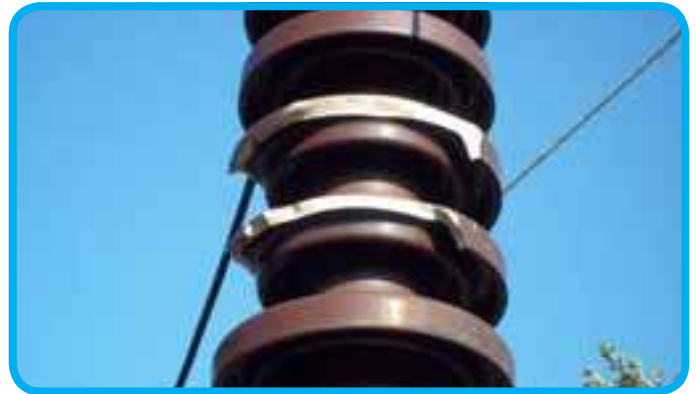
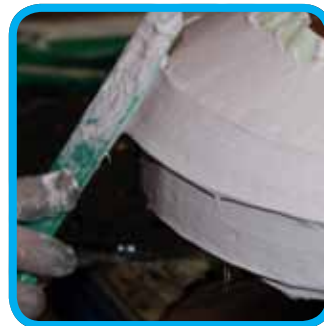
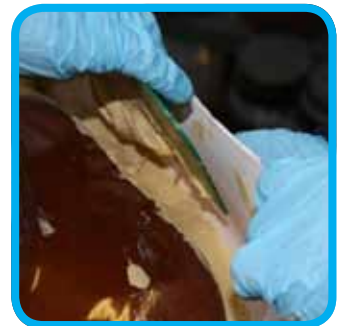
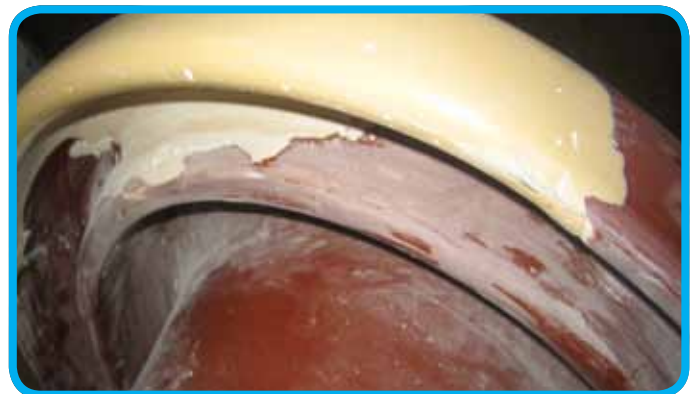
Several of the Flights / Sheds on the Insulator had been vandalised and were in need of repair. The cost of replacements is substantial and an on-site repair was sought by the customer. **Mark Specialist Applications** were called in.

The damaged Insulator was operating less efficiently than desired, and the alternative replacement costs and loss of supply / disruption we undesirable.

A mould was taken from a good part of the flight using a unique fast curing elastomeric polymer. After 10 minutes curing the mould was removed. The damaged profile was then rebuilt using a nonconductive epoxy repair paste, which is also fast cure.

The repair was dressed and then over coated with a high specification varnish to ensure complete surface encapsulation and thus effectiveness
