Customer Fast Ferry Operator, London
Sector Marine
Date May 2012
Ref no. 20055

APPLICATION EXAMPLE

Repairs to jet tube liners

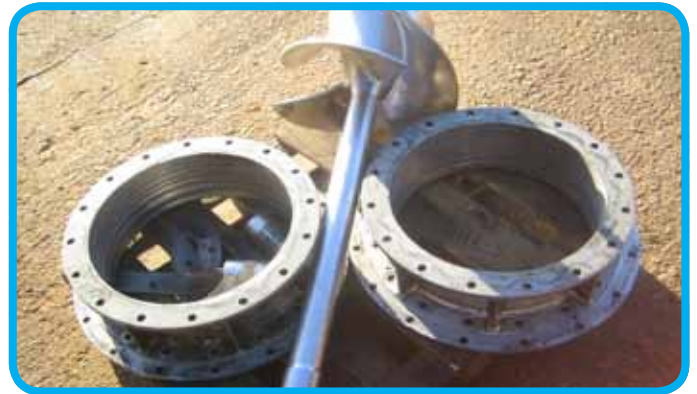
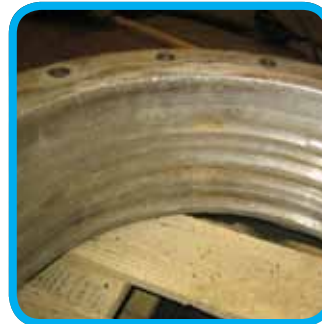
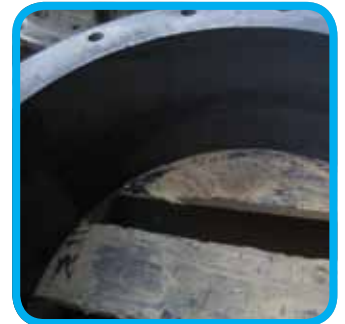
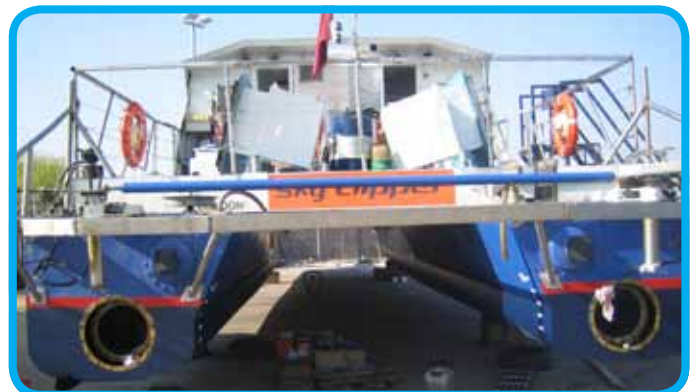
The aluminium jet tube liners had become badly scored and pitted due to high water volume and debris passing through at high speed. A fine tolerance is allowed between the impellers and liners to maintain efficiency which had been lost leading to decreased speed and loss of efficiency.

The liners and impellers were collected from Kent and brought back to our facility in North Wales. The liners were blast cleaned to the required standards with a non-metallic blast media, and rebuilt using a Resimac ceramic filled epoxy paste and left to cure. Once the epoxy paste had cured the rebuilt area was mechanically and hand dressed, each impeller was test fitted for size before a protective ceramic repair fluid was applied to give extra protection against abrasion.
