Customer Plastics Manufacturing Company, NW
Sector Manufacturing / Buildings & Structure
Date August 2012
Ref no. 20072

APPLICATION EXAMPLE

Repairs & coating to leaking paint separation tank

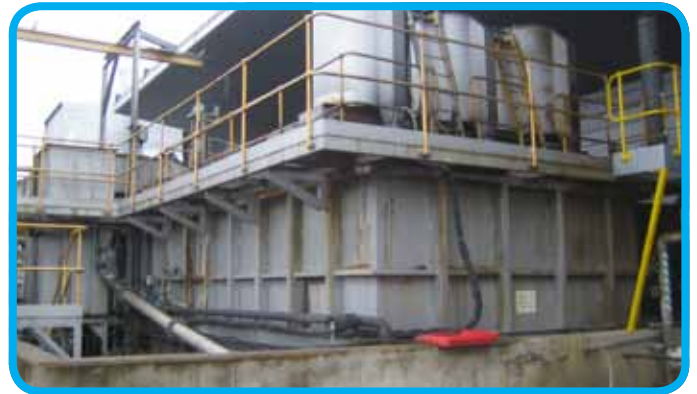
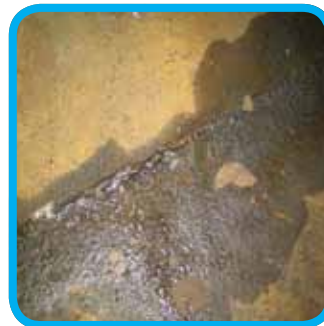
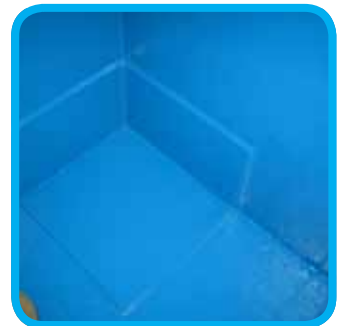
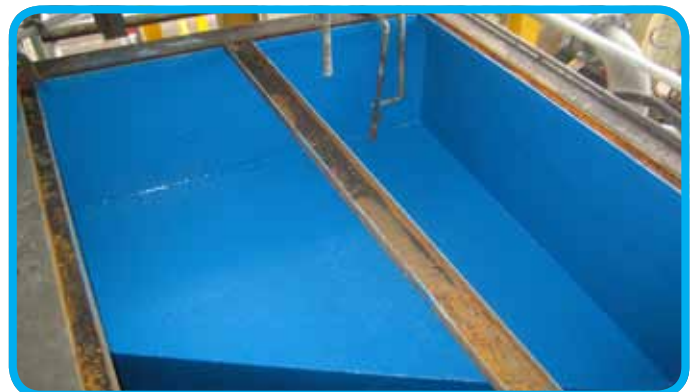
The paint separation tank was leaking from several small holes caused by corrosion / chemical attack. The condition of the steel tank was masked internally with a build up of paint and other chemicals. Due to the age of the tank the customer decided that it would benefit from the application of a long term protective coating, which was considerably more cost effective than a replacement.

A suitable time was chosen within the planned annual shutdown to drain the tank and blast clean the paint residue so the substrate could be inspected. It was found to have some severe pitting in areas and some very thin substrate which was leaking. Using cold plate bonding techniques the pitted areas and leaks were sealed without the need for any heat. The entire internal surface of approx. 180sq.m then received a 2 coat system of a high spec epoxy coating offering long term protection.
