Customer Chemical Company, North West
Sector Chemical / Petrochem
Date May 2012
Ref no. 20049

APPLICATION EXAMPLE

Repairs to process vessel main shell

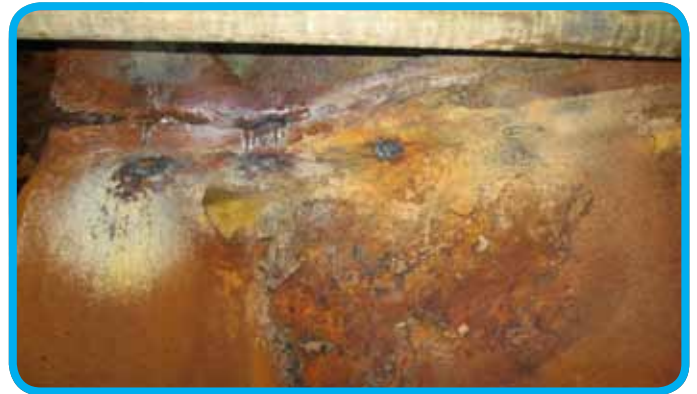
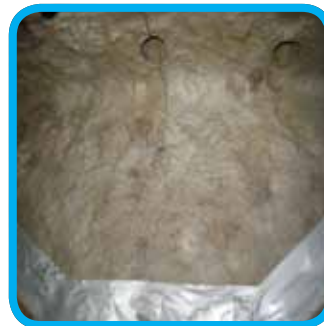
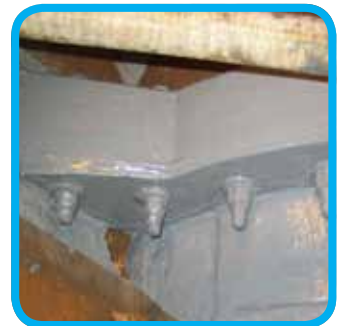
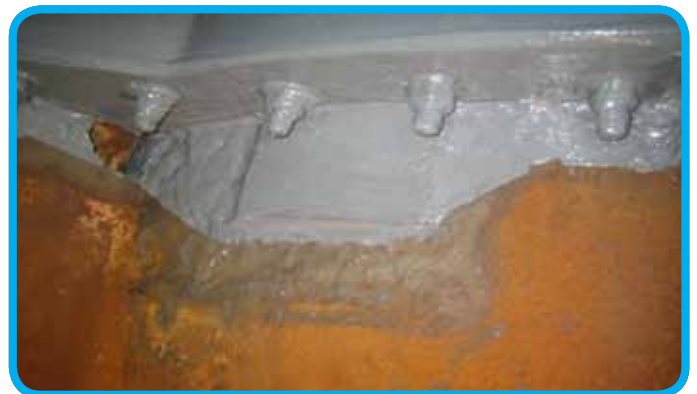
The blending tower external shell was found to be leaking from a crack. The crack started on the main connecting flange and ran through a bolt hole and into the main body of the vessel.

If the casting was left unrepaired the crack would have travelled further down the vessel which could have meant replacing the entire section of the tower meaning significant downtime and disruption to the process.

The crack was identified just in time to prevent a failure of the vessel section. The repair was classified as an emergency repair and was completed within 24 hours of notification and to the satisfaction of the insurance inspector.

The casting was blasted to SA2.5 and the extent of the crack inspected. The crack termination point was drilled to prevent the crack from increasing in size. Once the casting was cleaned the surface was re-built using Resimac 101 repair paste ready to cold bond the pre-manufactured plates. The plates ensured the integrity of the vessel by encapsulation the bolt holes and crack area. The repair was protected with a coating of high temperature Resimac ceramic repair fluid, 205 HT.
