Customer Manufacturing Company, North West
Sector Manufacturing
Date June 2012
Ref no. 20067

APPLICATION EXAMPLE

Repairs to pump impeller

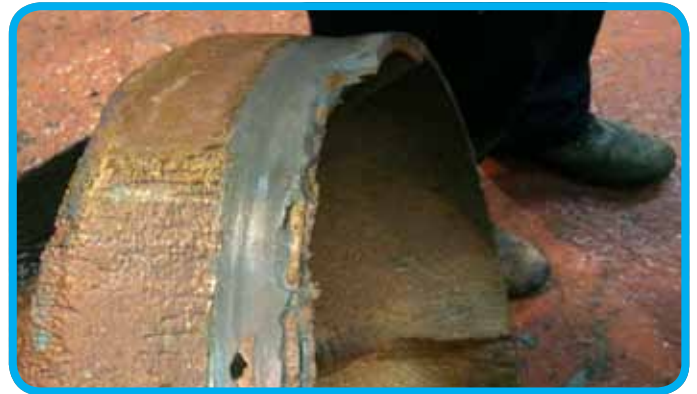
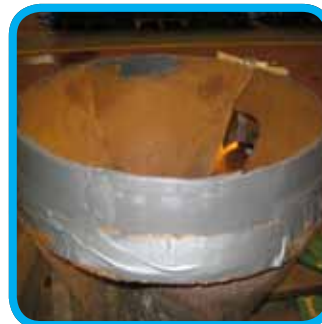
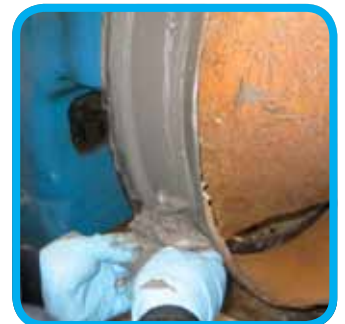
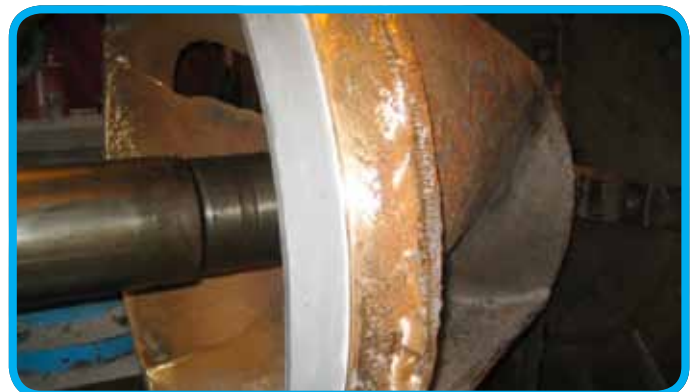
The pump was removed from service due to leakage and found to have mechanical damage to the impeller housing mating face.

The customer was considering scrapping the pump but decided to re-furbish instead due to the huge cost of replacement and extensive lead time. The pump was not working efficiently and causing process problems.

The damaged face was re-built using Resimac 101 repair paste which has excellent machining properties. The impeller was then put onto a lathe and machined back to the original spec.

Even with significant damage the pump can be re-build using high tech epoxy repair paste. With the mechanical properties of the repair paste the impeller was brought back to original tolerances and the customer saved a significant amount of money.
