Customer Irish Sea Ferry Operator
Sector Marine
Date July 2012
Ref no. 20058

APPLICATION EXAMPLE

Repairs to sea water filter

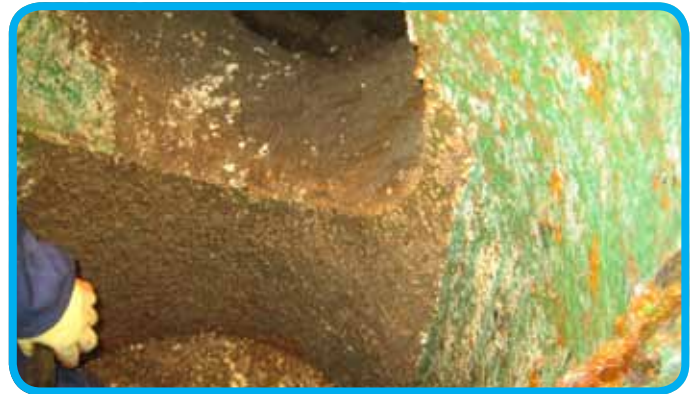
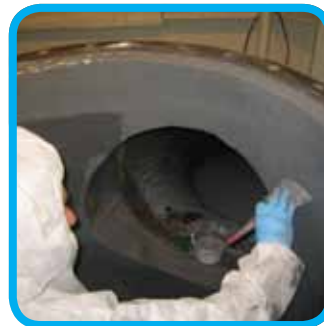
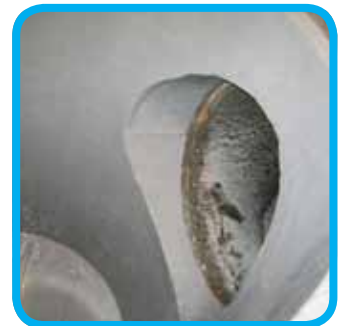
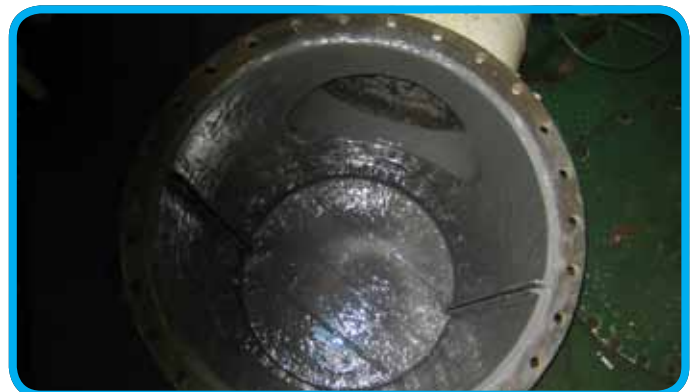
Although the vessel is only 7 years old the sea water filters used for ballast were found to be badly eroded / corroded.

Due to the location of the filters it was not possible to open blast the substrate so a vacuum blast system was used to remove the barnacles, rust and other debris that had collected on the surface. The heavy pitting was filled with Resimac ceramic filled epoxy and the first skim applied. Once cured with the assistance of a heater a second skim was applied to give a smooth finish. A ceramic filled repair fluid was applied over the repairs to give protection and leave an abrasion resistant finish.
