Customer Chemical Company, North West
Sector Chemical / Petrochem
Date July 2012
Ref no. 20070

APPLICATION EXAMPLE

Repairs to steam turbine mating flange

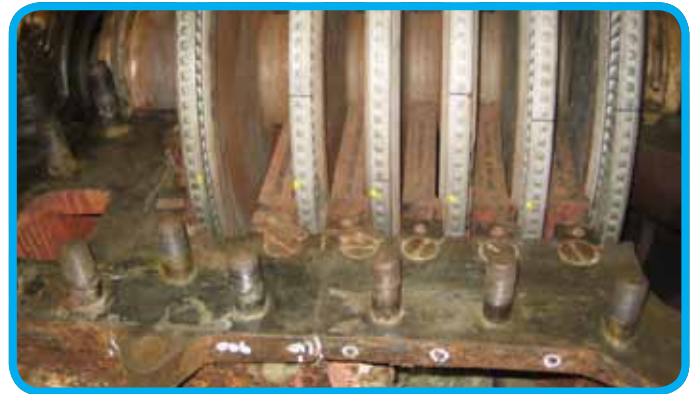
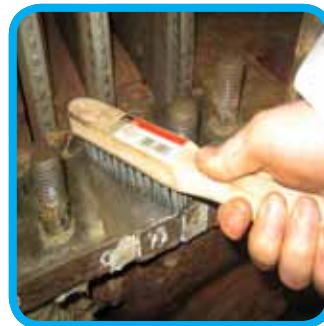
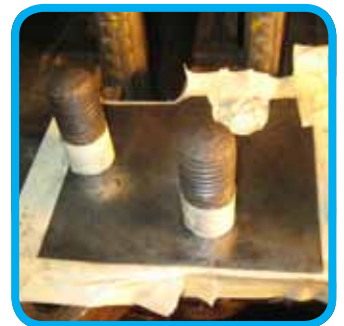
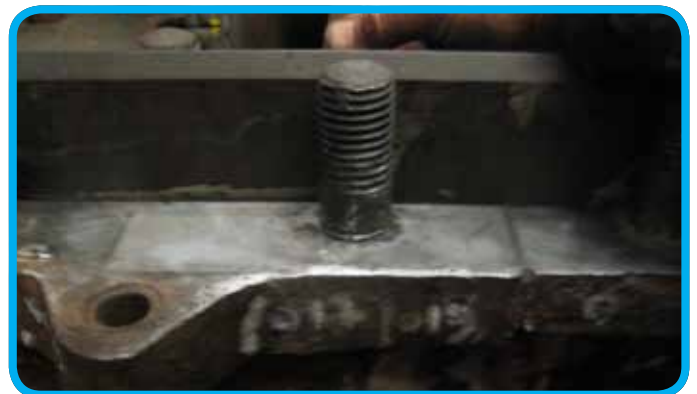
Whilst undergoing a major service it was found that the mating faces of the turbine castings were out of specification and could not be re-built without causing a significant high pressure steam leak. The turbine was needed back on-line as soon as possible as two other turbines were also on scheduled maintenance leaving no stand by capacity.

The repair specification was to re-build the low sections back to the OEM spec meaning 0.005" to 0.019" needed to be re-built on the mating face. The face surface was prepared using wire brush and emery cloth (blasting was out of the question due to possible contamination). The low areas were taped out and a specialised high temperature epoxy with very small fillers used to coat the low areas. The coating was hand dressed back to spec and the turbine was re-built and returned to service.
