**Customer** Tug Operator, Mersey  
**Sector** Marine  
**Date** June 2012  
**Ref no.** 20068

# Repairs to tug voith unit

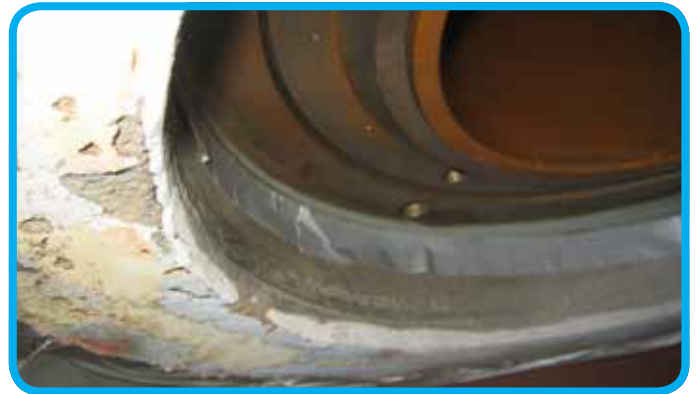
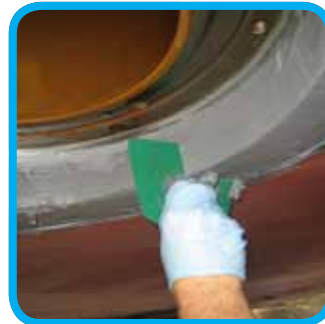
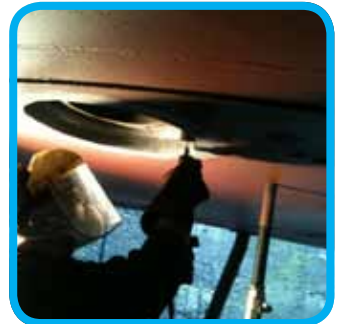
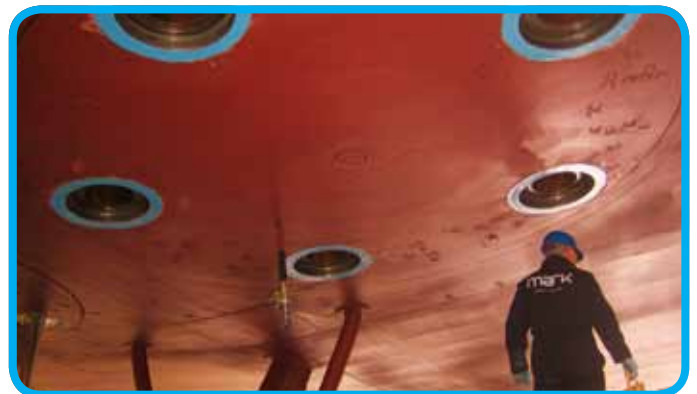
The O-ring seat on each blade housing had become corroded and pitted allowing water to seep into the mechanical gear box housing. To remove and machine the voith unit plate was out of the question and an in-situ repair was needed, so the owners called **Mark Specialist Applications** to seek expert advice.

Left untreated the problem would only get worse leading to substantial leakage / gearbox / efficiency issues.

The O-ring faces were rebuilt using Resimac ceramic filled epoxy paste and left on heat to cure. Once cured, the faces were mechanically and hand dressed to leave a smooth face for the O-ring to seal. The outer face was also filled using ceramic paste and a ceramic fluid was applied to give additional protection.
