Customer Chemical Company, North West
Sector Chemical / Petrochem
Date May 2012
Ref no. 20060

APPLICATION EXAMPLE

Absorber repairs to gas inlet pipe – confined space

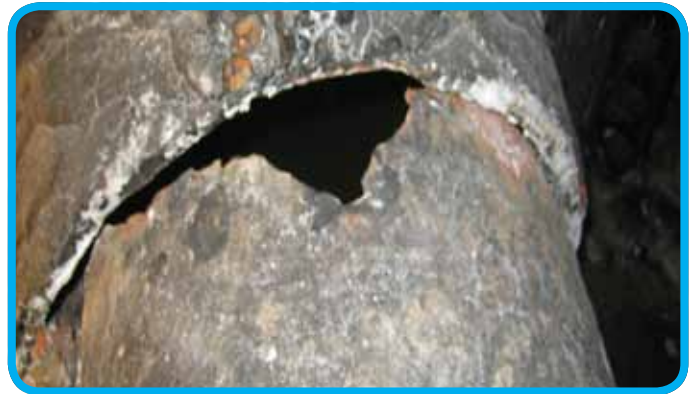
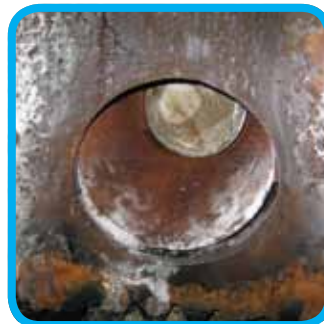
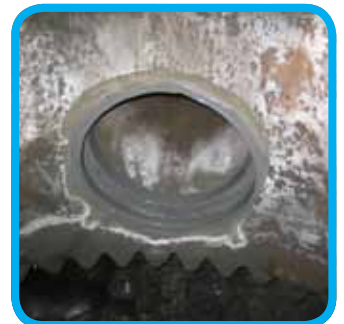
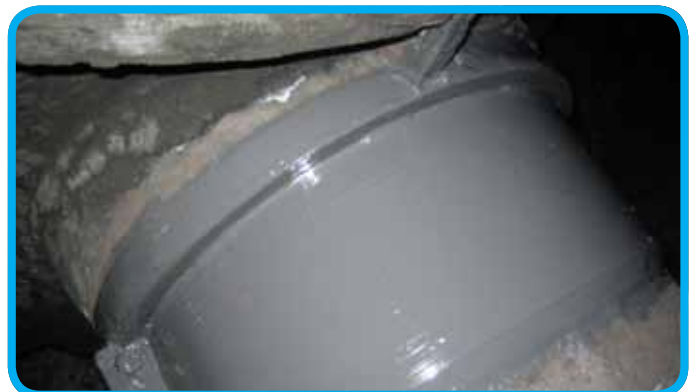
The main gas inlet pipe was found to have severe corrosion. The corrosion penetrated right through the steel leaving extensive holes in the pipe.

The loss of gas in the absorption process meant that the entire tower was losing efficiency and therefore costing a significant amount of money to produce less product.

The substrate was blasted to SA2.5 and pre-manufactured & rolled steel plates were cold bonded with Resimetal ceramic repair paste over the breaches in the inlet pipe. The repair was protected with a coating of high temperature Resimac ceramic repair fluid.

This project was an emergent repair which was required whilst we were on site carrying works on distillers. The plates were prefabricated and installed within 24 hours allowing the customer to move on with “boxing up” requirements.
