Customer Ship Repair Yard, France
Sector Marine
Date September 2011
Ref no. 20006

APPLICATION EXAMPLE

Repairs to bow thruster blades

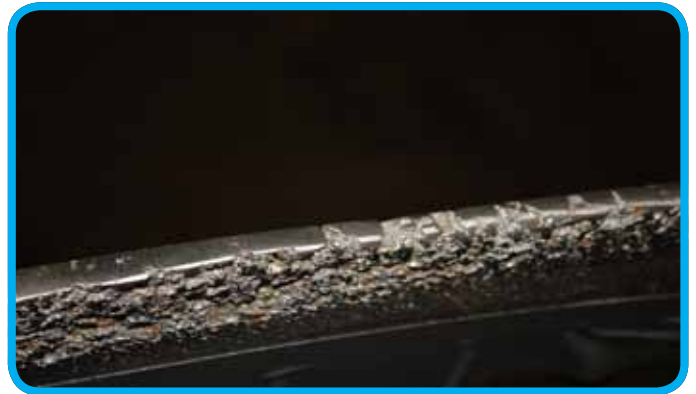
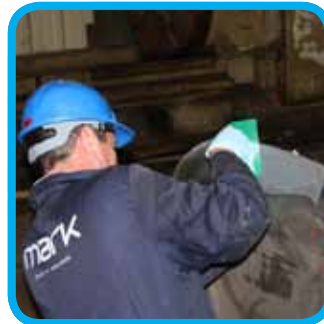
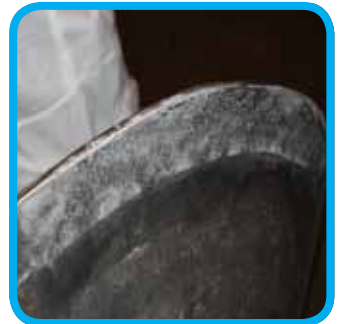
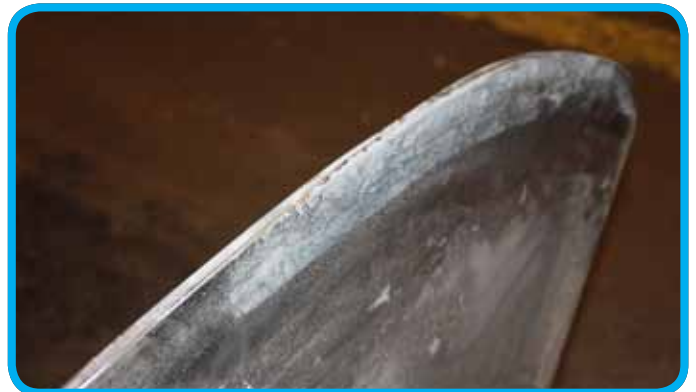
The container ship dry docked for its two year refit and it was found that the stainless steel bow thruster blades had severe erosion. The owners wanted to extend the working life of the vessel by an additional three years.

The bow thrusters blades had cavitation damage close to the tips which left untreated would have eventually broke off causing loss of efficiency, and ultimately the associated steering problems.

As replacement was out of the question the blades were hand prepared using mechanical wire brushes and chemical wipes. The cavitation areas were taped out and filled with Resimac Ceramic 201 repair paste. Upon curing the blades were hand dressed back to profile ensuring efficient operation and extended life.

The bow thruster blades were close to being scrapped which would have incurred substantial cost. With established repair techniques the blades were repaired and returned to service which saved the owners a substantial expense.
