APPLICATION EXAMPLE

Repairs to bow thruster tunnel

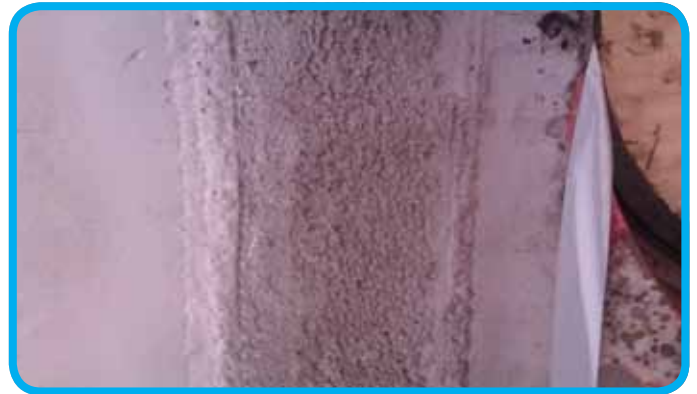
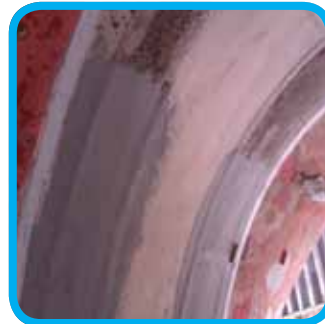
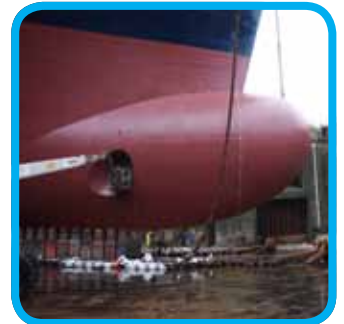
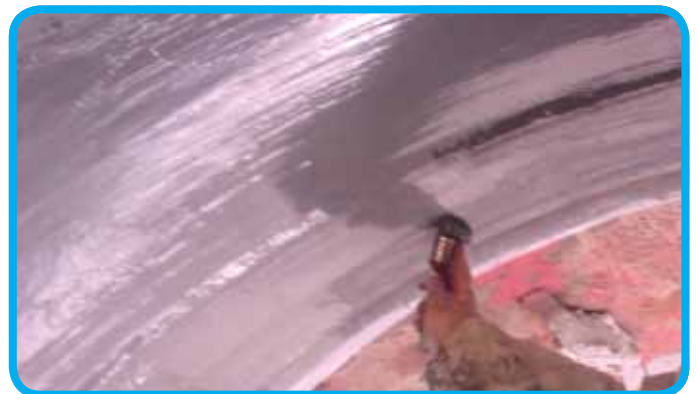
The container ship was inspected whilst in dry dock which revealed the 3mtr dia bow thruster tube was badly corroded with pitting depth ranging from 5-8mm.

Left untreated the pitting would get progressively worse and impact on the efficiency of this large bow thruster. In addition the thruster tube forms part of the hull and it's integrity, and breaches are extremely undesirable.

The complete circumference was blasted to SA2.5 to establish the extent of the corrosion. Resimac 201 ceramic repair paste was used to fill the deep areas back to the original spec, then a ceramic repair fluid (Resimac 202) was applied to protect the repaired areas.
