## APPLICATION EXAMPLE

# Repairs to spalled sills & lintels

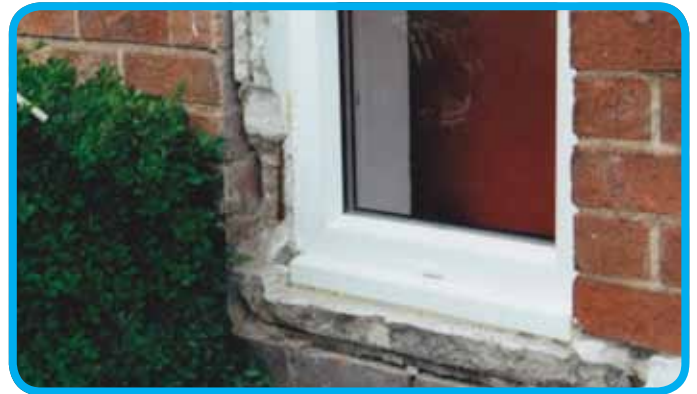
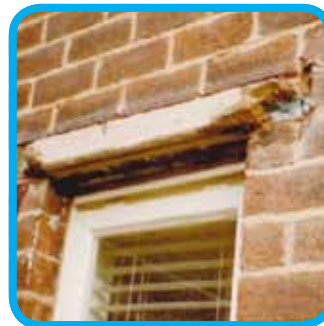
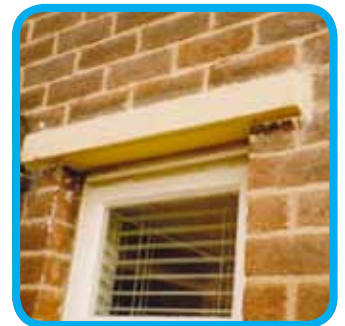
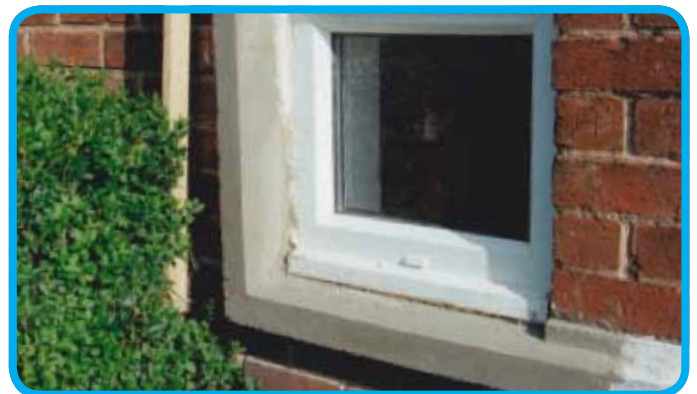
A local authority had a problem with severe spalling of window sills and lintels and **Mark** was called in to provide a quick and cost effective solution.

Left untreated the problem would increase leading to potential health and safety implications of falling concrete on passers by.

The defective concrete was removed. The damaged areas were rebuilt with lightweight epoxy repair cement and over coated with an anti-carbonisation coating.

The sophisticated lightweight mortar utilised requires minimal form work and cures fully within 8 hours thus allowing vast time savings on conventional type repairs.
