Customer Police Authority
Sector Buildings & Structures
Date June 1999
Ref no. 10632

APPLICATION EXAMPLE

Repairs to architectural concrete panel

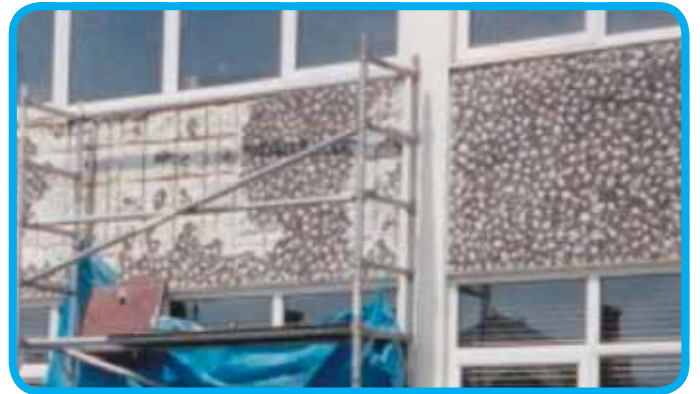
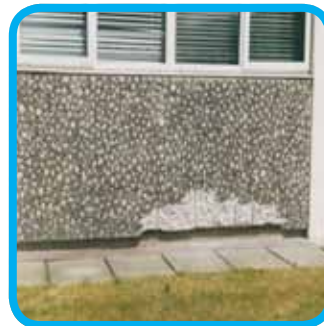
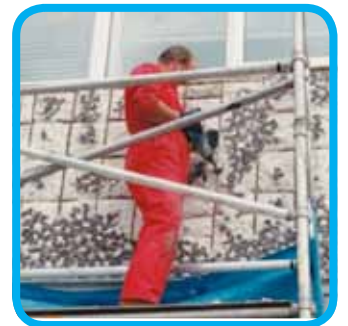
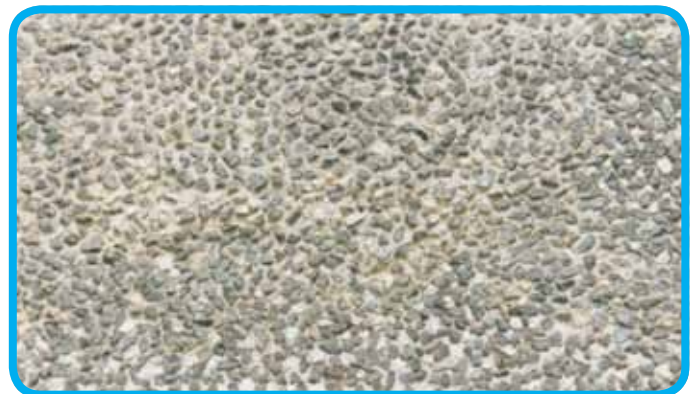
Fourteen architectural panels at a North Wales Police Station were suffering from carbonisation and the reinforcing bars had blown in many areas. The panels had become porous and required sealing to prevent further deterioration.

The defective concrete was removed. The damaged areas were rebuilt with a lightweight epoxy repair cement and all the panels were sealed with a clear coating.

This was an intricate job as all the original stones were resin bonded back into the epoxy repair cement one by one, but the end result was commended by the Senior Architect.
