APPLICATION EXAMPLE

Coating to cooling water inlet pipes

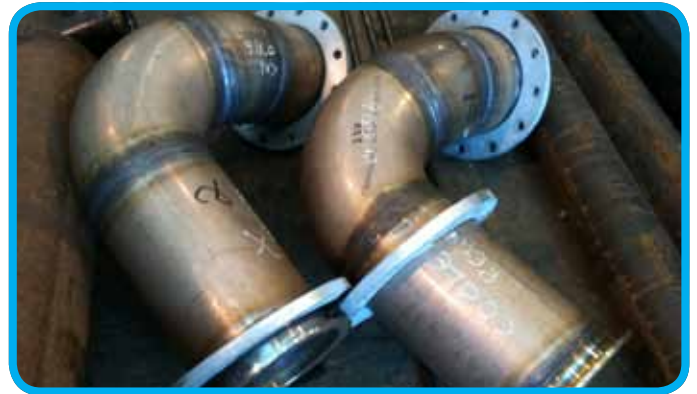
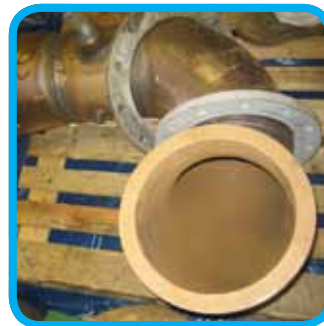
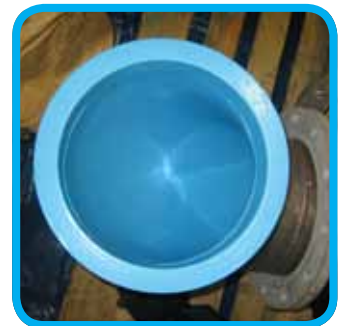
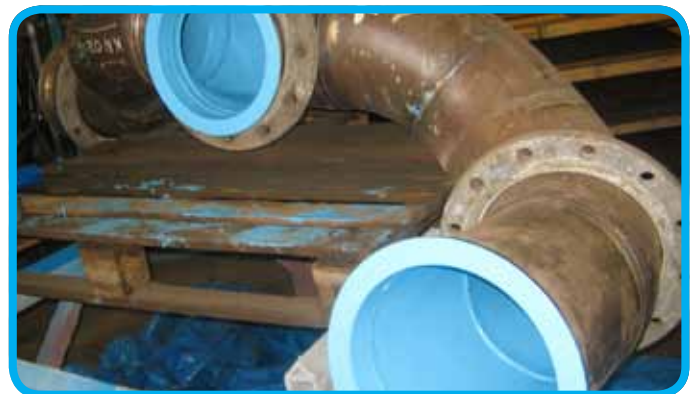
As part of a major overhaul of a large FRA vessel, it was decided that modifications to the existing cooling systems would be undertaken. As part of this modification new pipe spools were designed and fabricated. Due to excessive erosion noted in the original pipe work, part of the new specification included for the application of a long term protective coating to the internal surfaces.

The existing pipes were not able to be repaired as the internal corrosion had left the wall thickness too thin. Without new fabricated pipes the ships engine could not start.

The ship yard fabricated new pipes and to prevent corrosion they were blasted to SA2.5, and then received two coats of Resimac 203 ceramic repair fluid. The Resimac ceramic repair fluid has excellent abrasion resistance and smoothed out the welded areas to ensure a smooth flow.

The pipe spools were 12" dia, and intricate in design. **Mark Specialist Applications** was chosen to undertake these works due to our extensive experience in this environment.
