Customer Chemical Company, North West
Sector Chemical / Petrochem
Date February 2012
Ref no. 20033

APPLICATION EXAMPLE

Repairs to distiller floors – confined space

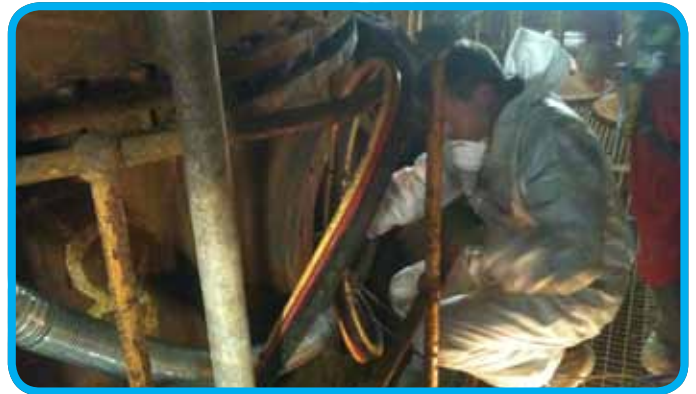
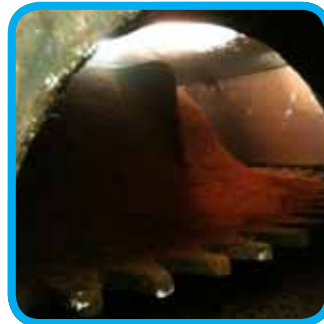
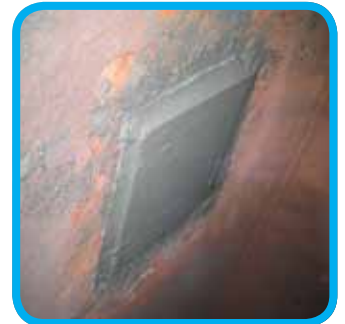
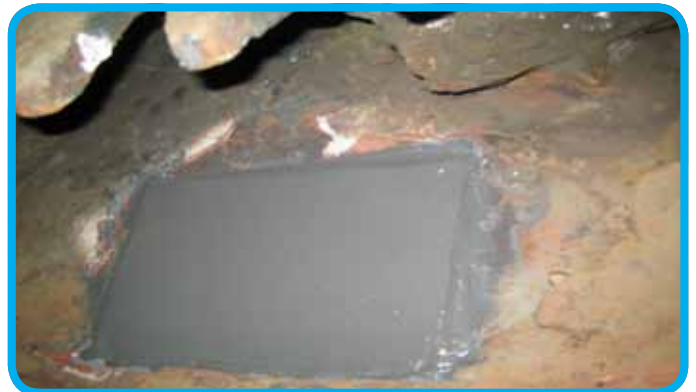
The distiller floors were found to have severe corrosion during its three year pressure vessel inspection. The corrosion penetrated right through the cast iron leaving holes.

The efficiency of the distiller was substantially reduced due to the holes allowing the liquor to leak to the compartment below, the loss of liquor at this stage leads to loss of efficiency, increased energy consumption and reduced output.

The substrate was blasted to SA2.5, the holes were filled with Resimetal 101, pre-manufactured steel plates were cold bonded over the breaches in the floor. The repair was protected with a coating of high temperature ceramic repair fluid – Resimac 205HT
