Customer Fertiliser Manufacturer - Teesside
Sector Water / Wastewater
Date June 2012
Ref no. 20057

APPLICATION EXAMPLE

Concrete repairs to effluent pit

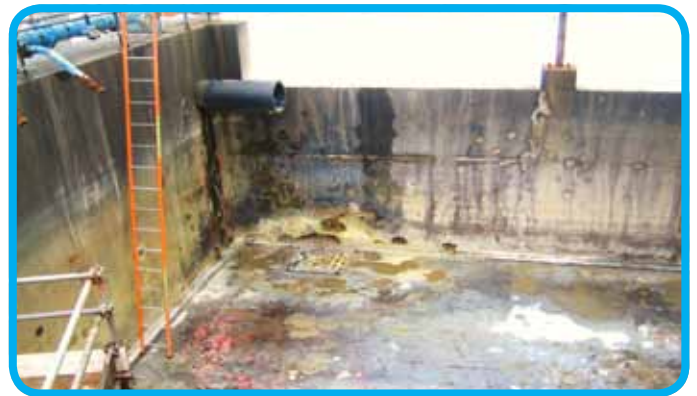
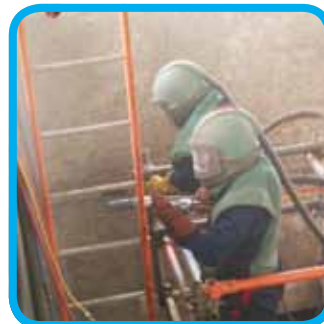
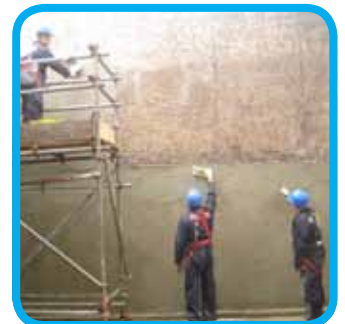
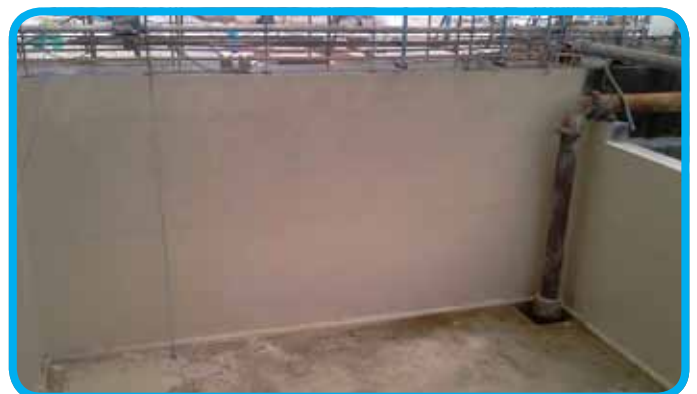
The water treatment pits on a Fertiliser Manufacturing plant were suffering from severe concrete deterioration. **Mark Specialist Applications** were called in to carry out the repairs and apply a long term protective coating.

The water treatment plant is a fundamental part of the whole manufacturing facility, and the concrete was so badly damaged in areas there was risk of the internal wall being breached to the adjacent pit. With either pit out of operation the plant would have to close down causing enormous downtime and associated costs.

The pit was high pressured washed, purged and cleaned out. The walls were blast cleaned to remove a previous coating. Concrete repairs were undertaken to refurbish the damaged walls and floors and the entire pit was sealed using a fully reinforced fibreglass system with outstanding chemical resistance.
