**Customer** Water Authority, North West  
**Sector** Water / Wastewater  
**Date** August 2010  
**Ref no.** 10977

# Long term protective coating to settlement tank – half bridge

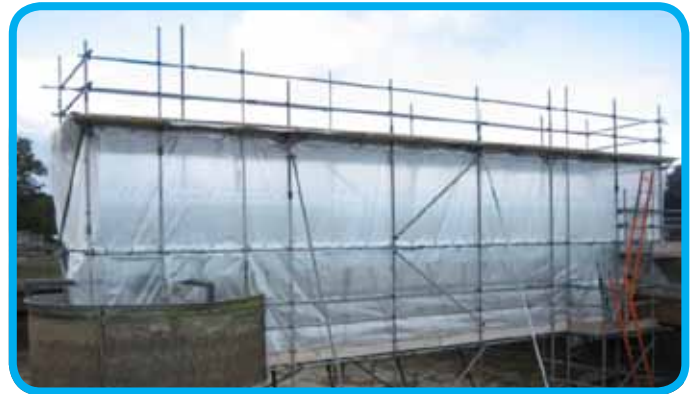
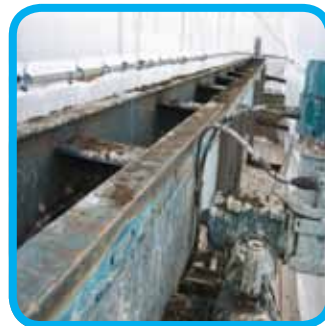
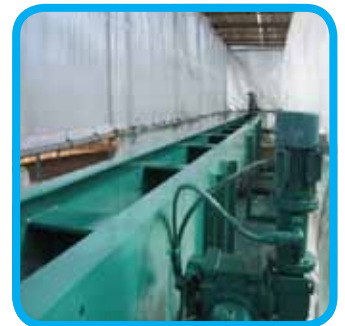
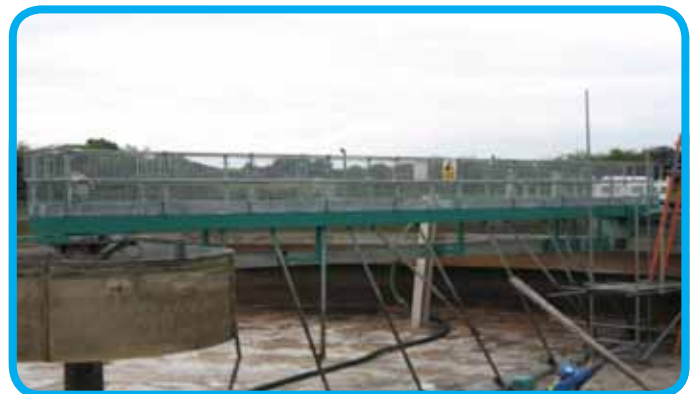
As part of a refurbishment project it was decided that the heavily corroded steel work to the half bridge required the application of a long term protective coating.

Left to further corrode in this aggressive environment would no doubt lead to a structural failure.

The half bridge was fully scaffolded and enclosed to protect the surrounding area from dust / over blast, and to also allow continuity of works during potential inclement weather. The entire structure was blast cleaned to SA2.5 with an average 75 micron surface profile. This was followed by 3 coats of high specification protective coating.
