Customer Chemical Company, North West
Sector Chemical / Petrochem
Date Feb 2012
Ref no. 20033

APPLICATION EXAMPLE

Distiller repairs – protective coating applied to multi-bubbler hood – confined space

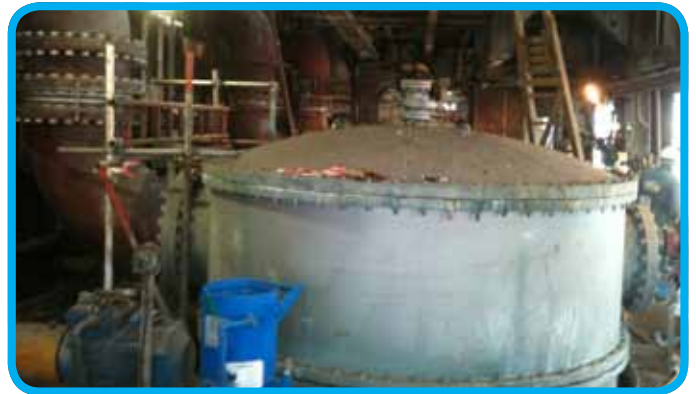
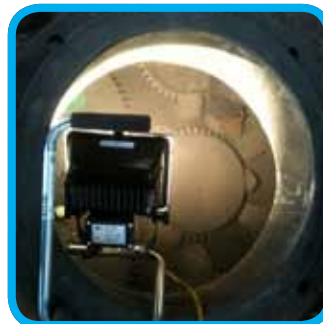
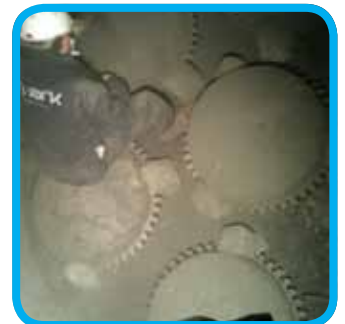
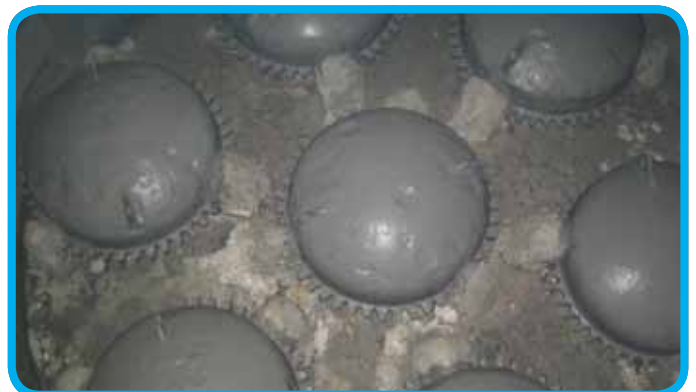
The multi-bubbler hoods were found to have surface corrosion due to chemical attack at high temperatures. Although still functional, it was decided that a prudent repair would be to coat the bubbler hoods to prevent more severe corrosion over the coming years.

Left unprotected it was only a matter of time before the bubbler hoods would become holed and thus less efficient in service.

The bubbler hoods were blasted to SA2.5 and re-inspected. A 900 micron layer of Resimac 205 HT ceramic coating was applied to protect the substrate from further corrosion.

The vessel was taken off line for the three year pressure vessel inspection and for repairs to the structure. This preventive repair will ensure that there will be minimum repairs needed the next time it comes off line.
