Customer Chemical Company, North West
Sector Chemical / Petrochem
Date April 2012
Ref no. 20048

APPLICATION EXAMPLE

Distiller repairs – bubbler hoods – extremely confined space

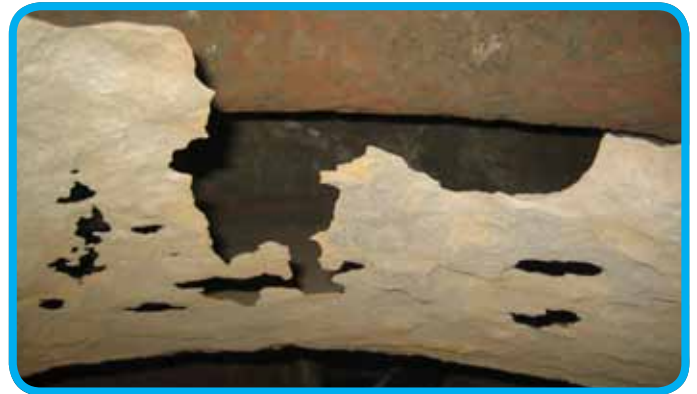
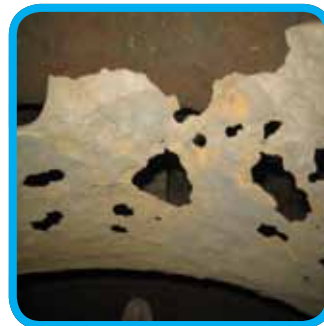
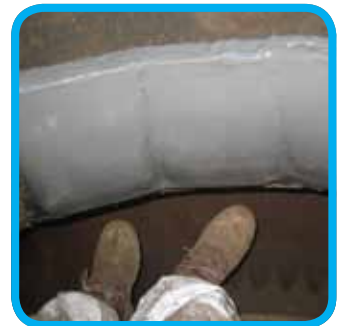
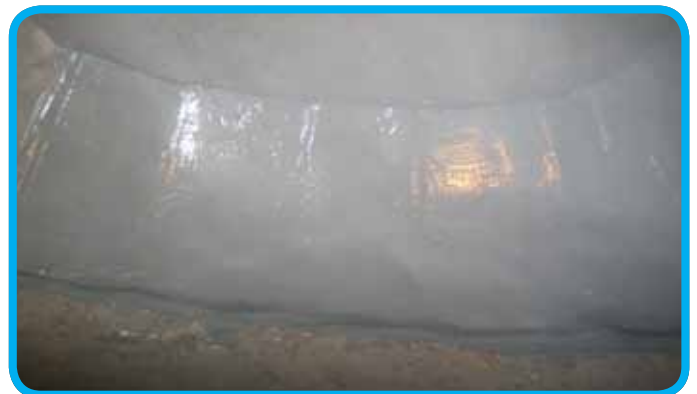
Several of the distiller hoods were found to have severe corrosion during the three year pressure vessel inspection. The corrosion penetrated right through cast iron leaving holes in the hood, in some places there was very little of the hood left.

What was left of the hood was blasted to SA2.5 and the extent of the damage inspected. The hood required a substantial repair using pre-manufactured plates to make up the missing profile. Once the hood was blasted the surface was re-built using Resimac 101 repair paste to cold bond the pre-manufactured plates. The repair was protected with a coating of high temperature Resimac 205HT ceramic repair fluid.

This significant repair was carried out in an extreme confined space and the integrity of the process was re-established. This repair would be more accurately described as a re-manufacture of the hood, which will out-live the remaining sections of the hood.
