Customer Container Ship Operator, France
Sector Marine
Date August 2011
Ref no. 20003

APPLICATION EXAMPLE

Pump casing rebuild & coating

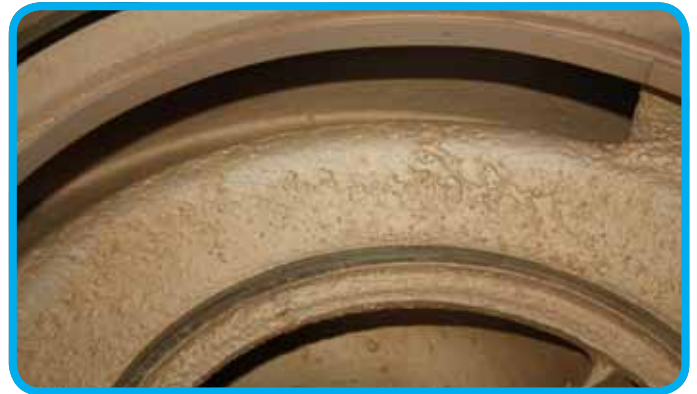
This fire water pump from a large container ship was due for its overhaul, and during its previous inspection it had been noted that there was evidence of erosion to the pump internals.

Mark Specialist Applications were contacted to collect the pump fully assembled from the quayside, arrange to dismantle it, carry out inspections, install where required new mechanical seals, V-seals, bearings etc. Following the completion of the above, the pump was rebuilt with ceramic repair paste and two coats of ceramic repair fluid.
