Customer Container Ship Operator, France
Sector Marine
Date August 2011
Ref no. 20005

APPLICATION EXAMPLE

Repairs to rudder leading edges

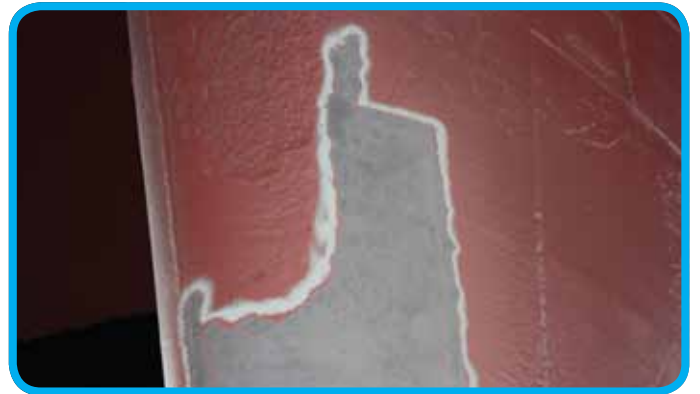
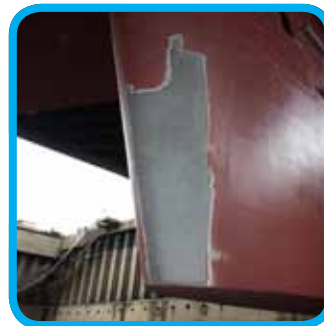
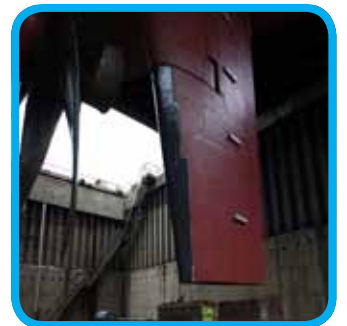
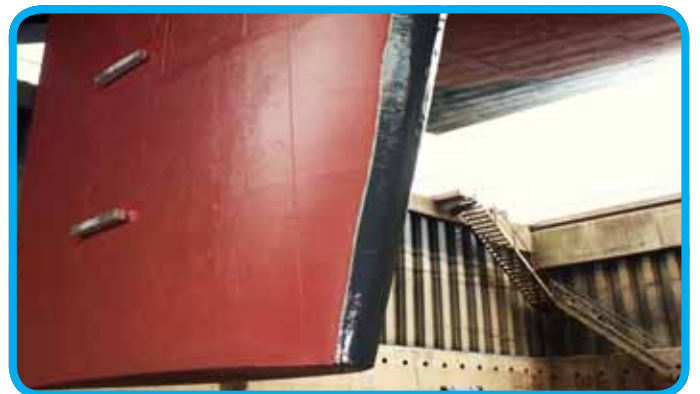
The rudder leading edges had become severely eroded during normal service back and to across the Atlantic. The dry dock survey had identified this and **Mark Specialist Applications** were requested to attend France to carry out repairs.

Left untreated the problem will only get progressively worse leading to expensive re-plating works.

The agreed areas were marked out then blasted to the required standards. The deep pitting was filled with Resimac 201 and the entire area protected with two coats of Resimac 202.
