**Customer** Electricity Supplier, North West  
**Sector** Power Generation  
**Date** December 2011  
**Ref no.** 20020

## APPLICATION EXAMPLE

# Repairs to leaking transformer

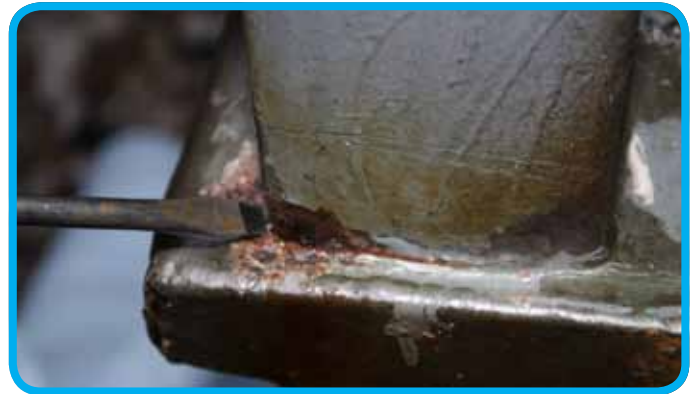
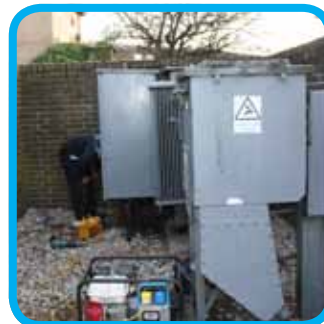
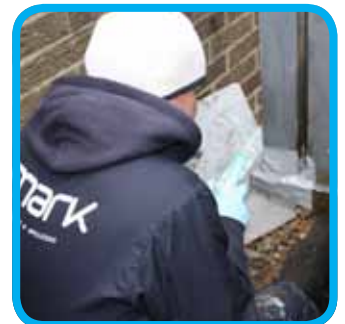
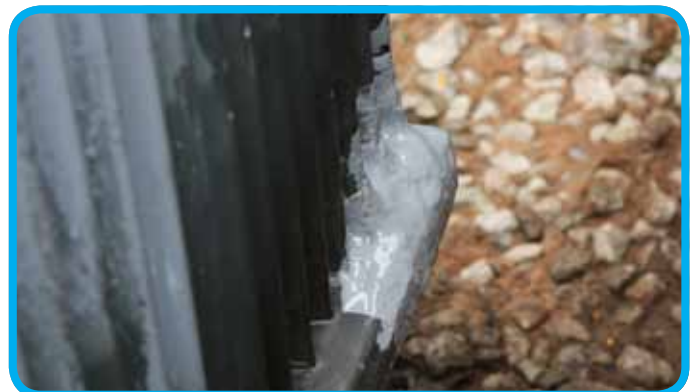
A transformer oil leak on a sub-station supplying domestic homes in Manchester was discovered during routine inspection. The oil was dripping onto the ground and lowering the cooling oil in the system.

This was a difficult repair to carry out as the substrate was contaminated with the transformer oil. Resimetal 104 has exceptional properties which actually absorb a small amount of oil to enable the repair to be effective. This repair saved the customer a consider cost, and they are now using Resimetal 104 to coat some of the older transformers in a preventive maintenance programme.

The substrate was cleaned using a wire brush to remove loose paint and rust. Due to the low ambient temperature the Resimetal 104 metal repair paste was heated to a workable temperature. A special Resimac metal repair stick was used to plug the hole and a coating of 104 applied.
