**Customer** Electricity Supplier, North West  
**Sector** Power Generation  
**Date** January 2012  
**Ref no.** 20021

# Repairs to cooling water pump bearing seats and coating

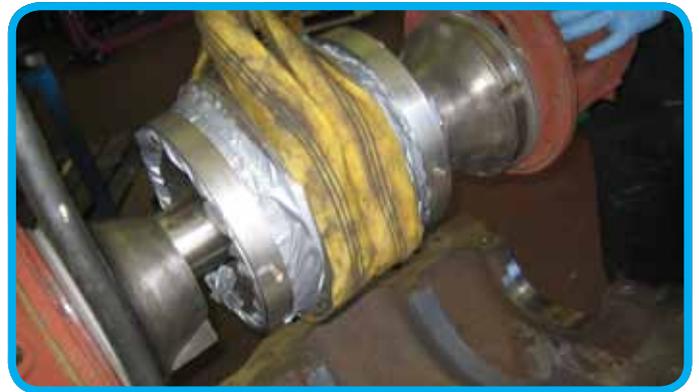
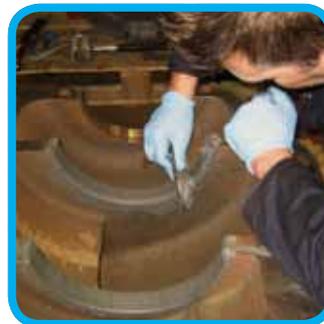
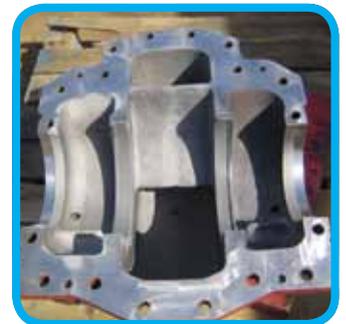
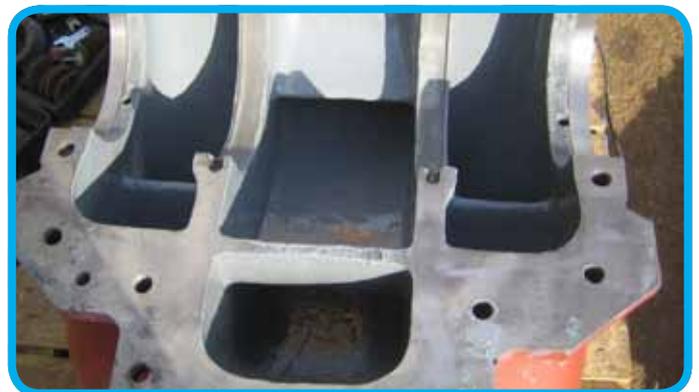
This pump was allowed to run dry and overheated to such an extent the casing cracked and the bearings seized and slipped in the bearing seats. The customer was considering a new replacement unit but decided that a repair attempt was feasible and potentially far more cost effective.

The works were carried out in conjunction with our "Partner Contractor" Pumtpec Engineering Services Ltd. Following initial blast cleaning the extent of the cracks became more evident, and we enlisted the assistance of Metalock Engineering Services to terminate the same. The bearing seats were blasted to SA2.5 whilst fabricated steel plates protected the rest of the casing and faces. The seats were rebuilt using Resimac metal repair paste and the bearings (with release agent applied) lowered in place to get an exact profile. Upon removal the bearing seats were dressed and the cast weld area was skimmed with metal repair paste. Once cured and dressed back a top coat of ceramic repair fluid was applied to complete the repair.
